CCU 1 - Digital Clock & VOR1/2 Modification

April 16 2004

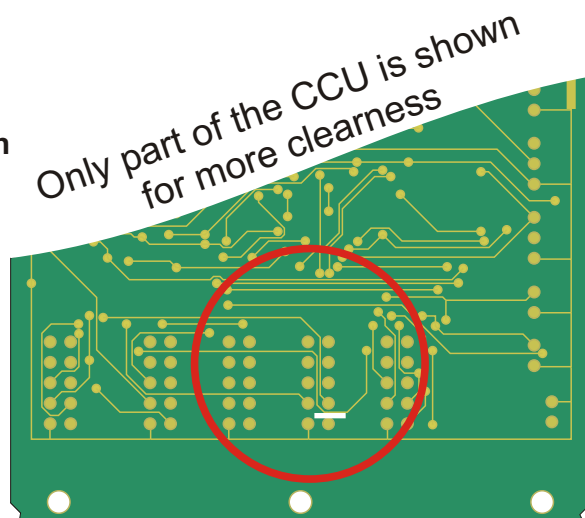
Due to design changes, the CCU1 Printed Circuit Board needs to be modified (when not done already by the factory) in order for the Digital Clock and the VOR1/2 to function properly! CCU1's (shipped before the 1st of April 2004) should have the modifications below. CCU2's shipped after this date have the modification(s) done during manufacturing.

Digital Clock Modification
Step one, Cut trace

Step 1: cut the trace on the back of the board as indicated by the black stripe in picture "Step 1" in order to free pin 2 of CN 14. Use a sharp knife. Be very carefull not to damage any other traces!

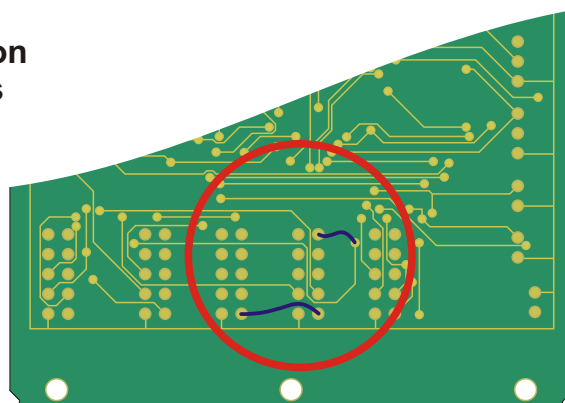
Digital Clock Modification
Step two, Solder 2 wires

Step 2: solder 2 new wires in place as shown on the picture "Step 2".

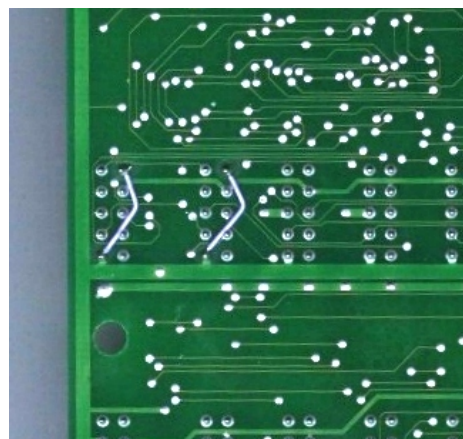
VOR1 & VOR2
Modification
Solder 2 wires

This requires only the soldering of 2 wires on the back side of connector C26 and CN27 between pin 1 and pin 10 as shown on the drawing below.
