CCU 1 - Digital Clock & VOR1/2 Modification

April 16 2004

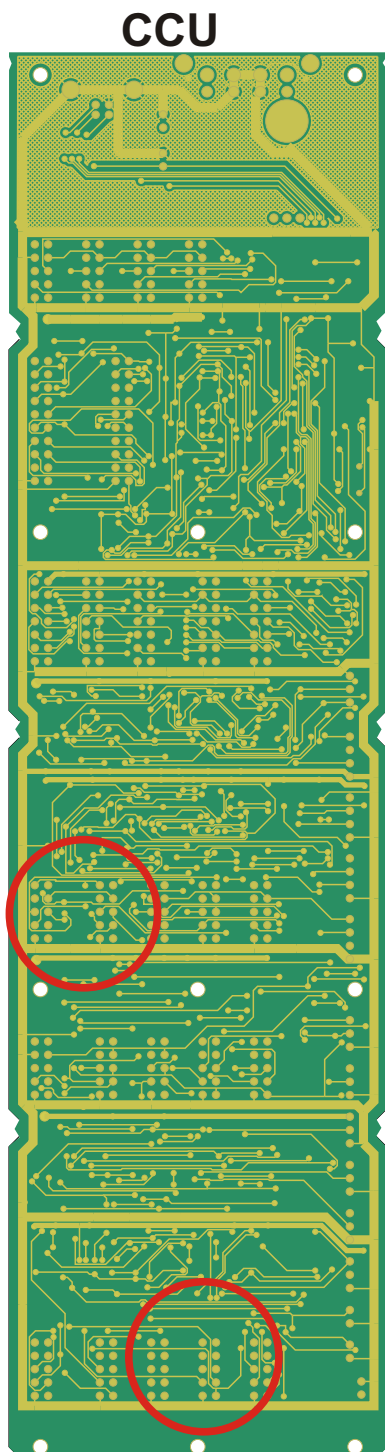
Step 1: cut the trace on the back of the board as indicated by the black stripe in picture "Step 1" in order to free pin 2 of CN 14. Use a sharp knife. Be very carefull not to damage any other traces!

Digital Clock Modification
Step one, Cut trace
